RESEARCH REPORT  
B2003/0114

# Review of Midair Collisions Involving General Aviation Aircraft in Australia between 1961 and 2003

**Review of Midair Collisions Involving  
General Aviation Aircraft in Australia  
between 1961 and 2003**

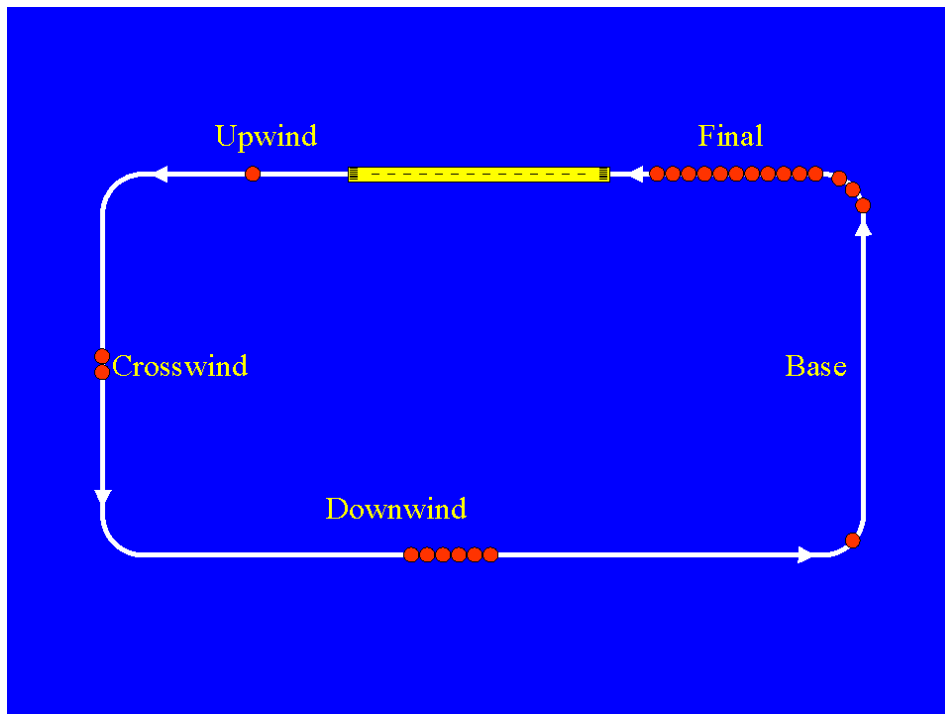
**Figure 1: Diagrammatic representation of positions of midair collisions in the circuit area**

The diagram does not discriminate between left and right circuit patterns.

Eleven of the collisions occurred when both aircraft were on final approach, two occurred during the base-to-final turn, and one occurred on the turn to base. The collision at Moorabbin in 1968 occurred either on the base leg or the final approach. Six collisions occurred on the downwind leg (one with an aircraft departing) and two occurred on the crosswind leg (one with an aircraft departing). One collision involved two aircraft on initial climb. Figure 1 presents a diagrammatic representation of the location of collisions in the circuit area. The dots indicate in which leg of the circuit the collisions occurred rather than the specific location within each leg.

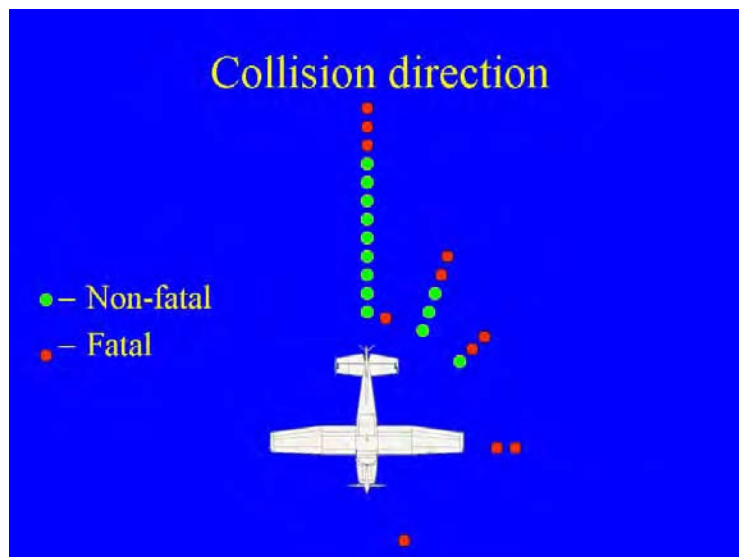
**Figure 2: Diagrammatic representation of collision angles involved in collisions not involving deliberately close flying activities**

The diagram does not include collisions with gliders, or collisions where aircraft were flying deliberately close.

- Most (18) of the collisions involved one aircraft colliding with another from behind, or both aircraft converging from a similar direction (less than 30 degrees difference in heading), and only six of these collisions resulted in fatalities. Twelve of these collisions occurred at a height of 250 ft or less above the ground, with only three resulting in fatalities. Of the 12 collisions with collision angles 30 degrees or greater, 11 resulted in fatalities.<sup>11</sup> All of these collisions occurred at heights greater than 250 ft. Figure 2 provides a diagrammatic representation of the collision angles involved in the midair collisions.

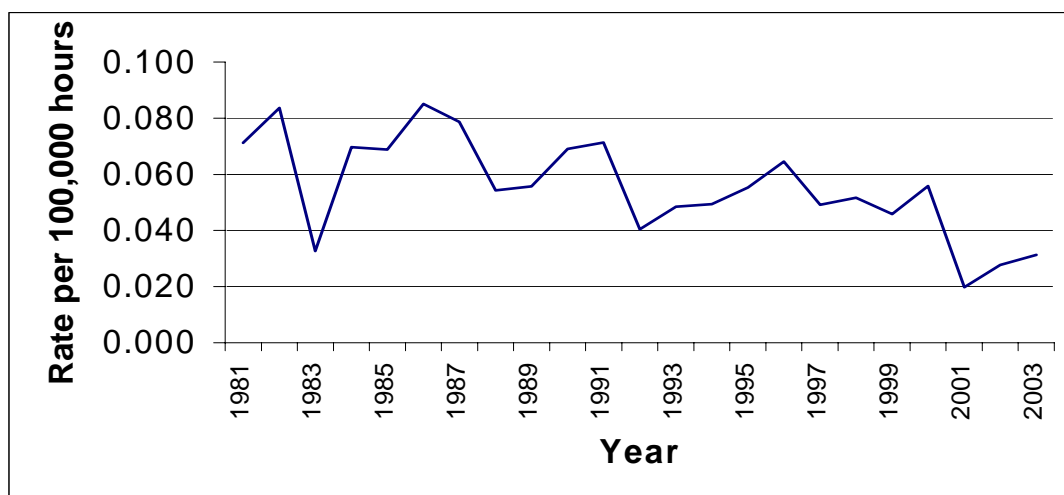
**Figure 3: Rate of midair collision accidents for the US per 100,000 flying hours for the period 1981-2003**

Figure 3 shows the rate of midair collision accidents per 100,000 flight hours in the US for the period 1981-2003. The rate appears to have decreased over that period. A comparison of the rate between the period 1981-1990 and 1991-2003 was statistically significant.<sup>18</sup> The reasons for the decrease in midair collision rate involving general aviation aircraft are not known.

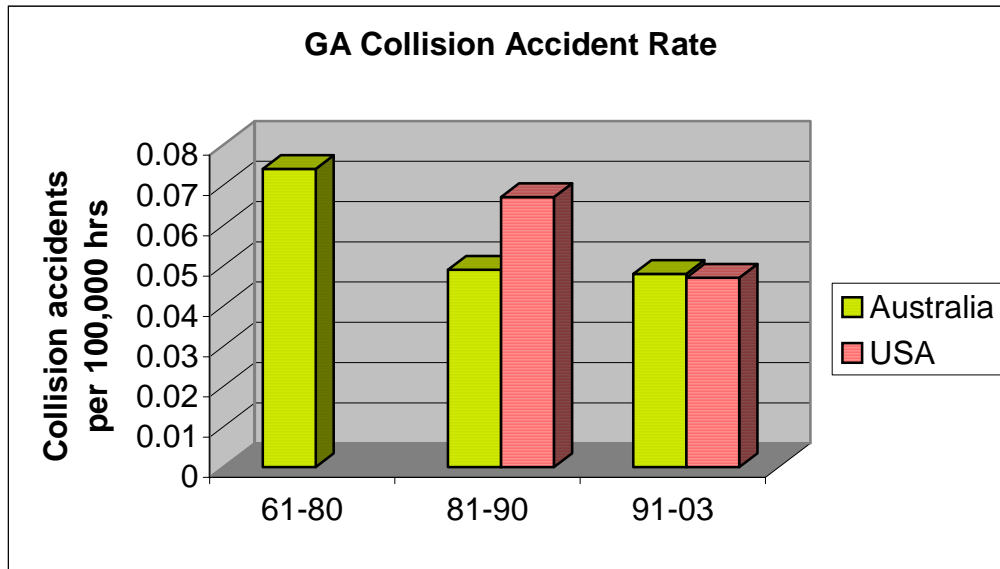
**Figure 4: Comparison of midair collision accident rate between Australia and the US for general aviation**

Figure 4 shows a comparison of the midair collision accident rate per hours flown for general aviation aircraft in Australia and the US. The figure indicates that the US may have had a higher rate of collisions during the period 1981-1990, but the two countries had a similar rate during the period 1991-2003. Overall, the difference between the two countries for the period 1981-2003 (0.048 in Australia and 0.056 in US) was not statistically significant.<sup>25</sup>

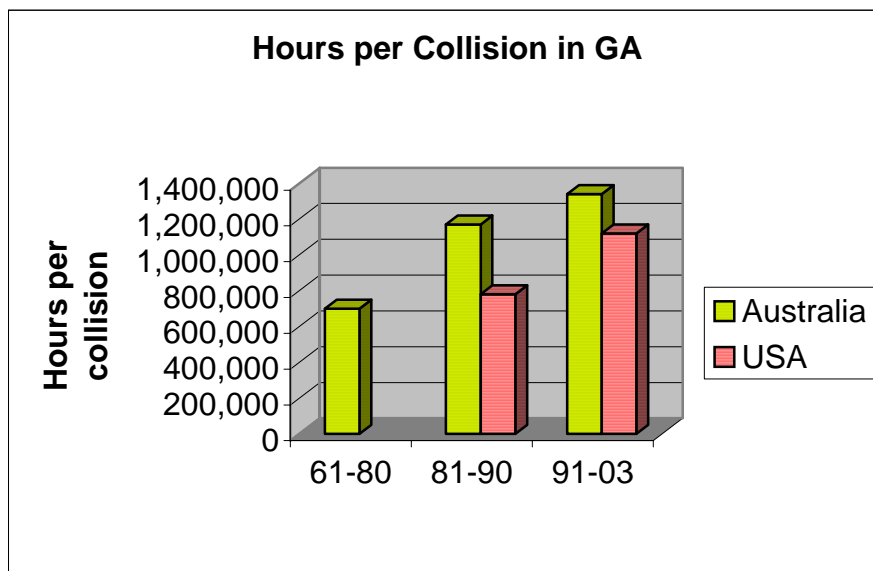
**Figure 5: Comparison of flight hours per collision between Australia and the US for general aviation aircraft**

Figure 5 shows a comparison between Australia and the US in terms of the hours flown per collision for general aviation aircraft. Overall, for the period 1981-2003, the US had a lower number of hours flown per collision (930,000 hours) for general aviation aircraft relative to Australia (1,260,000 hours), indicating that general

aviation in the US may have had a slightly higher risk for midair collisions. However, this difference was not statistically significant.<sup>26</sup>
